**Reference: Howey Bay Road Bridge and Forestry Road Culvert - OSIM Bridge Inspections 2021
Summary Letter**

2021 OSIM Visual Inspections
Howey Bay Bridge
2021-12-14

2021 OSIM Visual Inspections
Forestry Road Culvert
2021-12-15

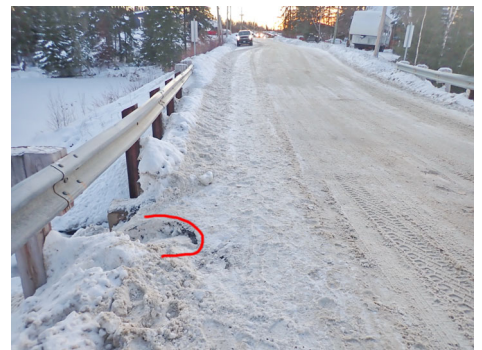
Element Group:	Approaches	Length:	7.00				
Element Name:	Wearing Surfaces	Width:	7.40				
Location:		Height:	0.10				
Material:	Asphalt	Count	2				
Element Type:		Total Quantity:	103.60				
Environment:	Benign <input type="checkbox"/> Moderate <input type="checkbox"/> Severe <input checked="" type="checkbox"/>	Limited Inspection	<input checked="" type="checkbox"/> Snow / Ice				
Protection System:						Perform. Deficiencies	Maint. Needs
Condition Data:	Units m ²	Exc.	Good	Fair	Poor*	08	12
Comments: Light ravelling typical. East approach on South side has embankment loss with missing asphalt (0.6x0.9) encroaching the travel lane.							
Recommended Work: None <input type="checkbox"/> 6-10 Years <input type="checkbox"/> 1-5 Years <input type="checkbox"/> <1 Year <input checked="" type="checkbox"/> Urgent <input type="checkbox"/> Repair asphalt on SE corner in conjunction with SE embankment repair.

Approaches - Wearing surface - SE.
 Note: Missing asphalt encroaching travel lane.

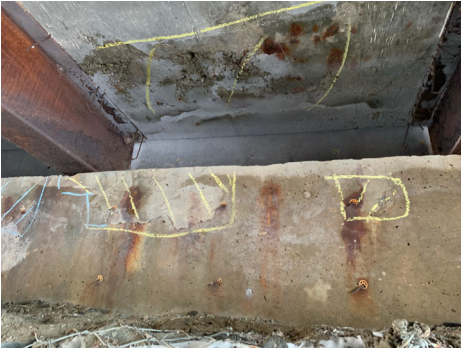
SU1 Abutment wall. Note: Typical delamination and rust staining.

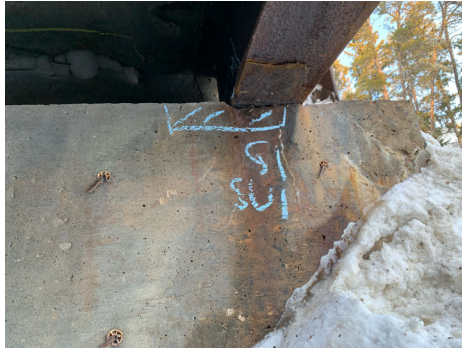
Comments:
Light bulging typical. Girder bottom flanges are very close to touching the abutment seat and SU1 G1 has caused a mechanical spall on the abutment concrete under the girder.

SU1 Abutment wall. Note: Spall below G1.

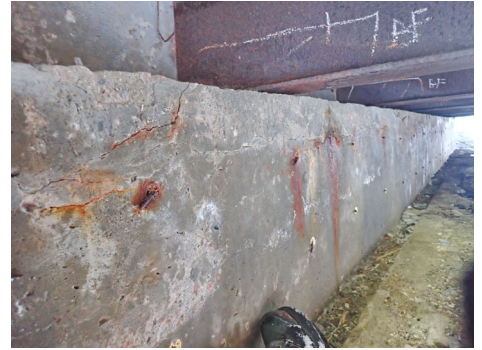
SU2 Abutment wall. Note: Typical delamination and rust staining.

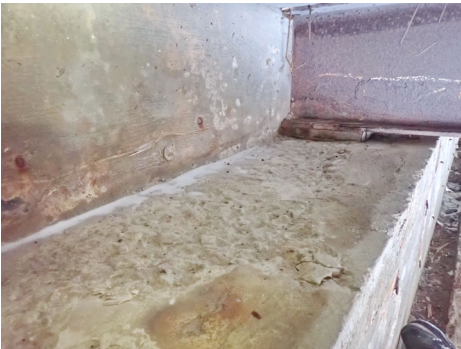
SU2 Abutment wall - between G1/G2. Note: Disintegration of bearing seat.

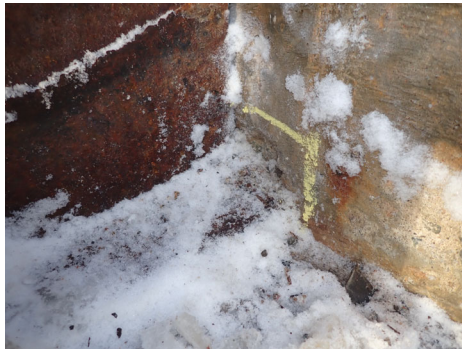
SU1 Ballast wall - SE. Note: Mechanical spall behind G1 bottom flange.

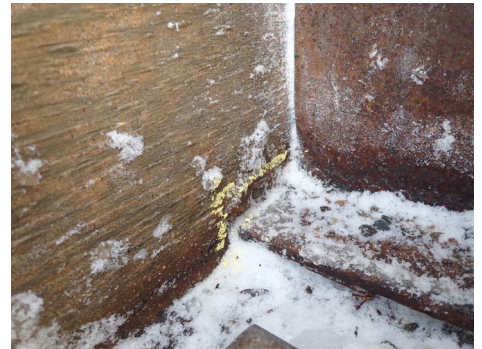
SU1 Ballast wall - NE. Note: Mechanical spall behind G6 bottom flange.

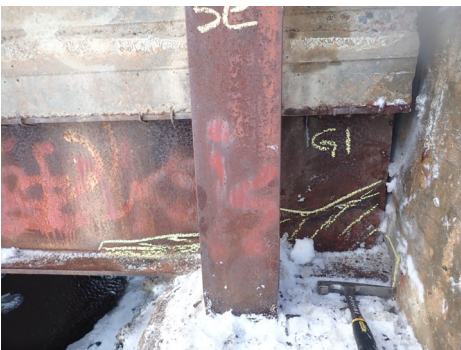
G1 @ SU1. Note: Medium corrosion on web.

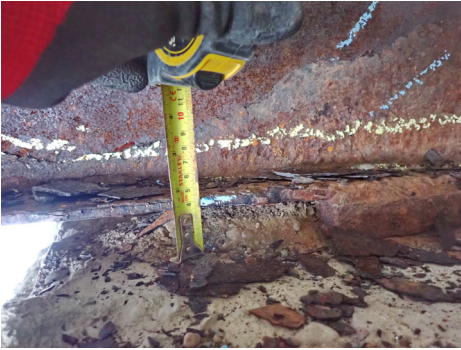
Comments:
 Light corrosion typical. Medium corrosion at the ends throughout. SU1: Isolated area of severe corrosion on the web. Typical severe corrosion and section loss on bottom flanges up to 8mm at SU1 and 3mm at SU2. (Flange thickness should be ~12mm)

G2 @ SU1. Note: Severe section loss on the bottom flange.

Based on the condition of the girders and the movement of the abutment Stantec recommends replacing the bridge with a new structure in approximately 1-5 years with a lifespan of 75 years. An example of a new structure would be a new 12.0m long by 7.2m wide concrete channel girder bridge with an estimated cost of \$734,400.

Recommended Work: None ☐ 6-10 Years ☐ 1-5 Years ☒ <1 Year ☐ Urgent ☐
 Recommend replacing bridge.

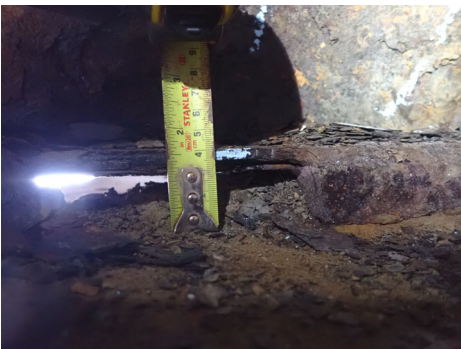
G5 @ SU1. Note: Severe section loss on the bottom flange.

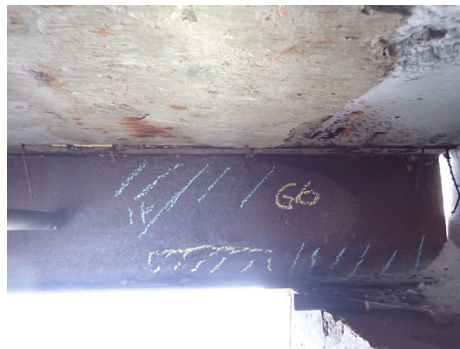
G6 @ SU1. Note: Medium to severe corrosion on web.

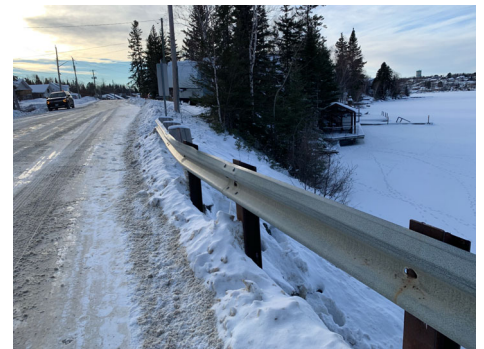
Comments:
 Isolated light corrosion. Isolated permanent deformations. No other observed defects.

Railing - North. Note: Permanent deformation.

Recommended Work: None ☐ 6-10 Years ☐ 1-5 Years ☐ <1 Year ☒ Urgent ☐
 Replace section of north railing from deck Post 3 to west approach Post 1.

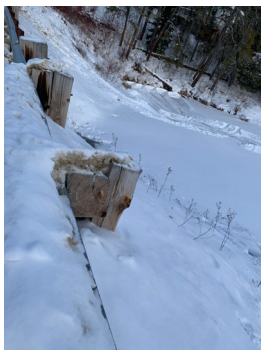
Comments:
Light weathering typical. Medium to severe checks/splits. SW: Post 3, rotated blocking; Post 4, missing blocking. NE: Post 1, non-standard sizing (0.1m L x 0.1m W). Bottoms of Post 1 at SW, SE, and NW are moving out due to loss of supporting embankment material.

Approach Railing - SW. Note: Broken blocking at Post 4.

Recommended Work: None ☐ 6-10 Years ☐ 1-5 Years ☐ <1 Year ☒ Urgent ☐
Replace SW Post 4 blocking.

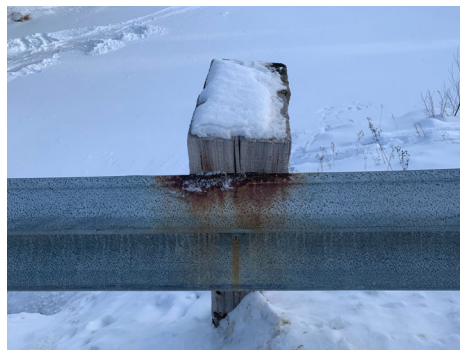
Coatings - Railing. Note: Typical rusting.

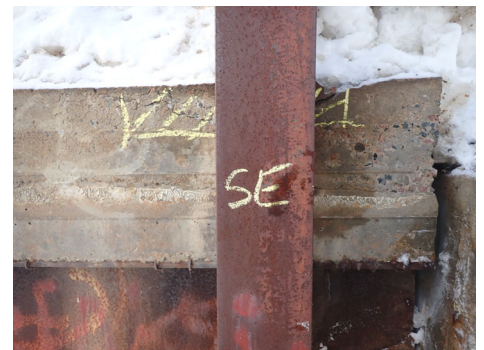
Deck Soffit - Exterior - SE side. Note: Spall behind post.

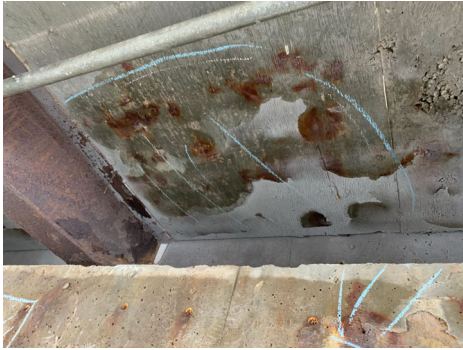
Deck Soffit - Interior - SU1. Note: Typical delamination.

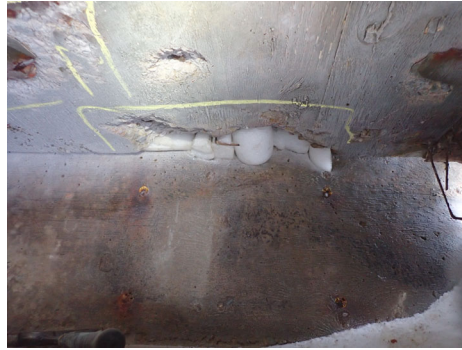
Comments:
 Light scaling typical. Light to severe honeycombing. Rust staining at the abutments. Typical delaminations and spalls with exposed corroded reinforcement at the abutments. Full depth section loss at SU1 between G1/G2 (~0.6x0.2) temporarily repaired with foam to support wearing surface.

Deck Soffit - Interior - SU1 between G1/G2. Note: Spall and temporary repair.

Recommended Work: None ☐ 6-10 Years ☐ 1-5 Years ☐ <1 Year ☒ Urgent ☐
 Repair spall at SU1 between G1/G2 with structural concrete.

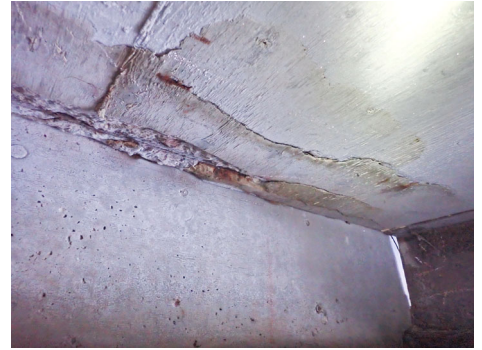
Deck Soffit - Interior - SU2 between G4/G5. Note: Typical delamination, spall, and exposed rebar.

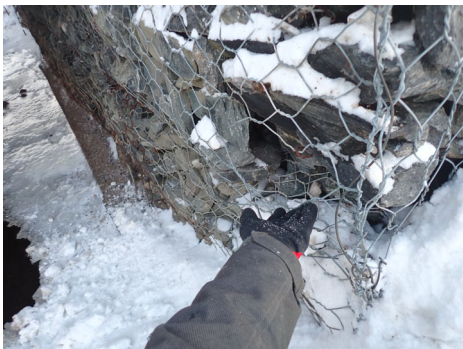
Comments:
Limited inspection due to snow on the embankments, exposed areas of the embankments appear to have no observed defects. Gabion baskets in front of abutments have areas of light to severe corrosion with some section loss of the wire especially along the bottom of SU1 and SU2. No significant movement observed.

Slope Protection - SU2. Note: Typical hole in wires.

Recommended Work: None☐ 6-10 Years☐ 1-5 Years☐ <1 Year☒ Urgent☐
Repair wire on gabion baskets at the bottom of SU1 and SU2.

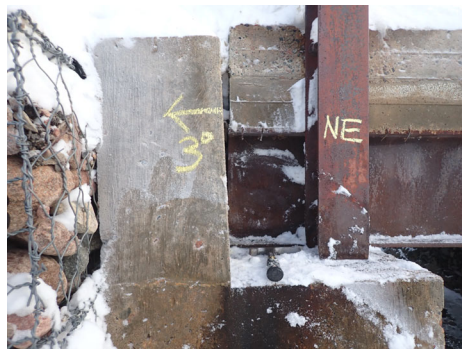
Foundation - NE. Note: Gap between deck top and ballast wall at SU1.

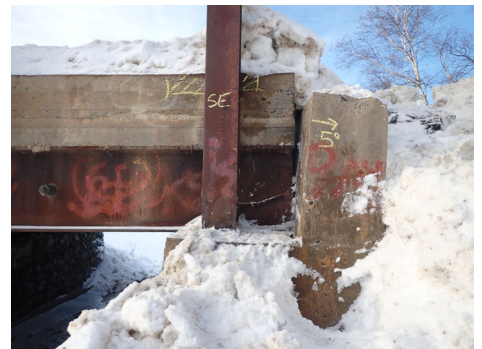
Foundation - SE. Note: Gap between deck top and ballast wall at SU1.

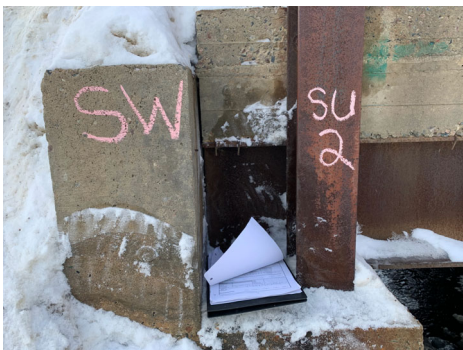
Foundation - SW. Note: Gap between deck top and ballast wall at SU2.

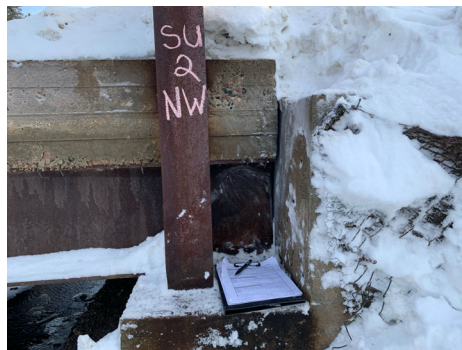
Foundation - NW. Note: Gap between deck top and ballast wall at SU2.

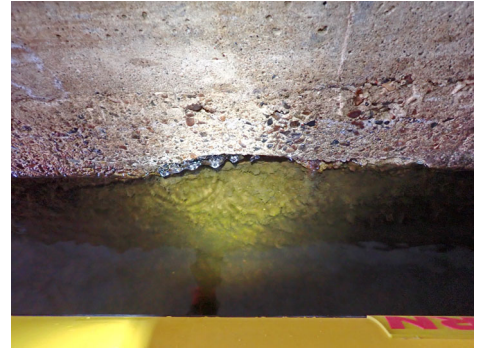
Culvert North Footing. Note:
Disintegration and erosion of concrete footing with exposed rebar.

Due to limited access, an underwater investigation of the concrete footing was completed in 2017. It is recommended that another underwater investigation be completed to monitor the extent and rate of concrete footing deterioration until the repair is completed. Underwater investigation should compare and contrast to the investigation completed in 2017.

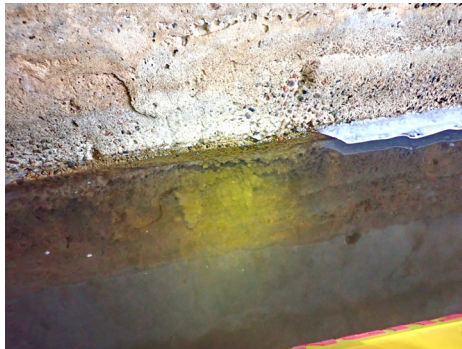
Culvert North Footing. Note:
Disintegration and erosion of footing with exposed rebar.

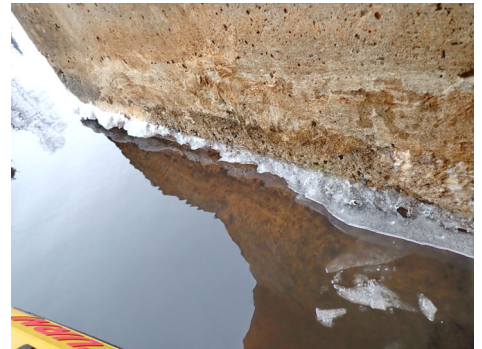
Culvert South Footing. Note:
Disintegration and erosion of concrete footing with exposed rebar.

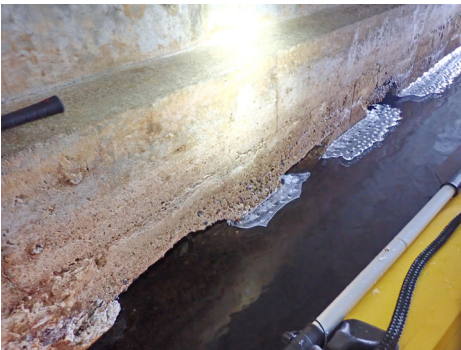
Culvert South Footing. Note:
Disintegration and erosion of concrete footing with exposed rebar.

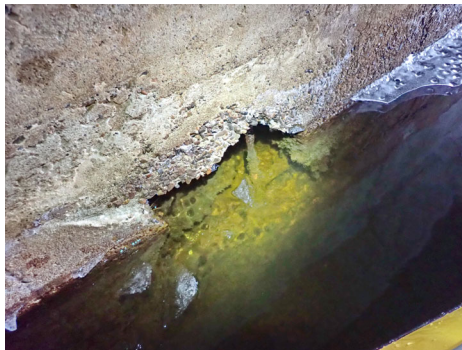
Culvert South Footing at midspan. Note:
Disintegration (~450mm deep) of footing with exposed rebar.

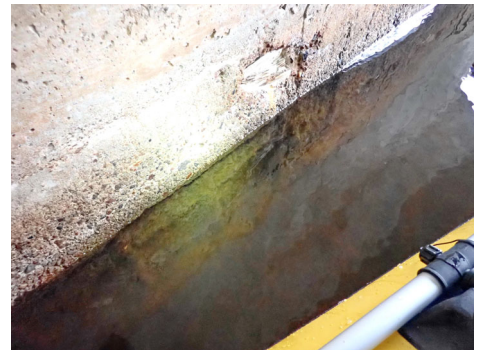
Culvert South Footing. Note:
Disintegration and erosion of concrete footing with exposed rebar.

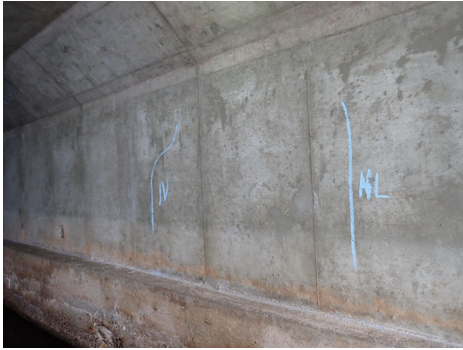
Culvert Barrel - South wall. Note typical vertical cracks.

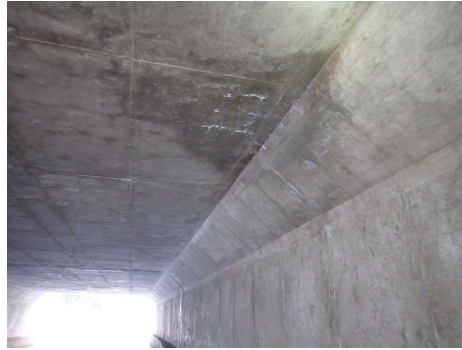
Culvert Soffit near Inlet. Note: Isolated active wet area with hairline cracks.

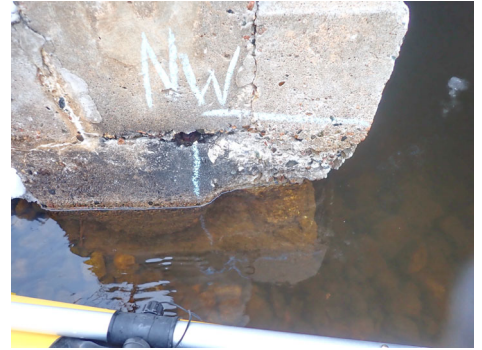
Inlet - NW corner. Note: Disintegration and erosion of concrete footing with exposed rebar.

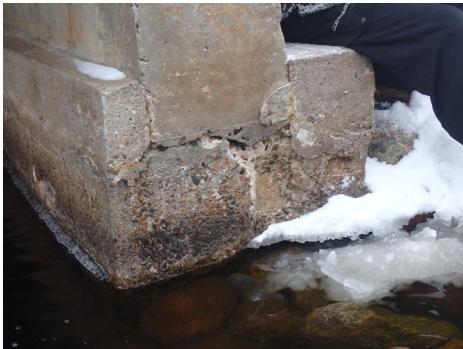
Inlet - SW corner. Note: Disintegration of footing

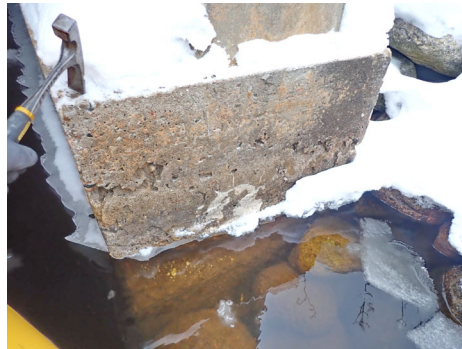
Outlet - NE corner. Note: Disintegration and erosion of concrete footing.

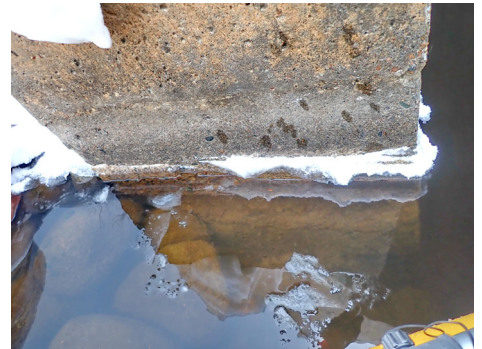
Outlet - SE corner. Note: Disintegration and erosion of concrete footing.
