**Reference: Howey Bay Road Bridge and Forestry Road Culvert - OSIM Bridge Inspections 2021
Summary Letter**

2021 OSIM Visual Inspections
Howey Bay Bridge
2021-12-14

2021 OSIM Visual Inspections
Forestry Road Culvert
2021-12-15

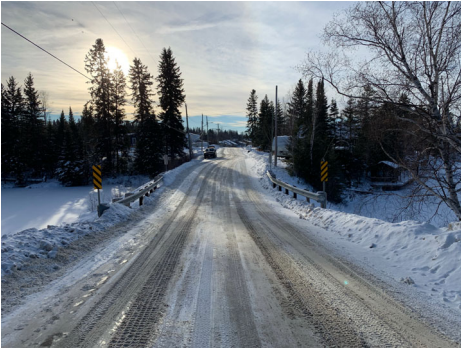
Looking West towards SU1.

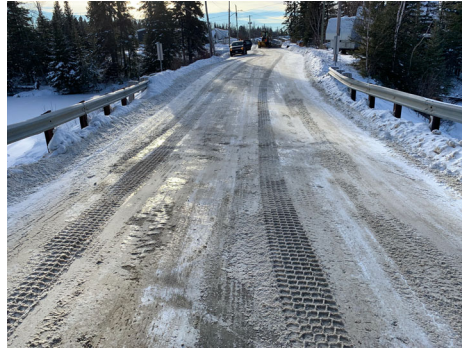
Typical Wearing Surface.

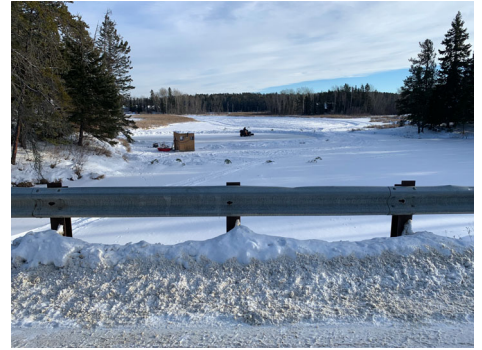
Upstream looking South.

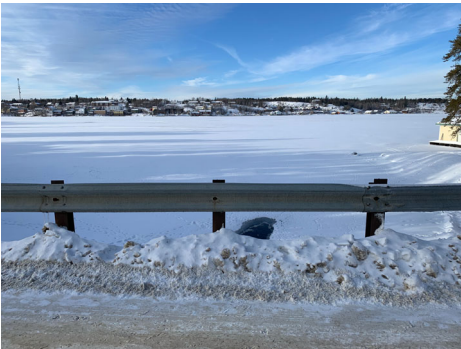
Downstream looking North.

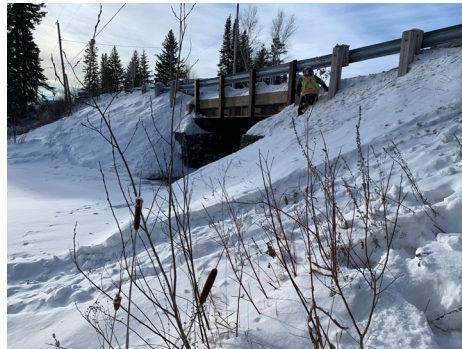
South elevation.

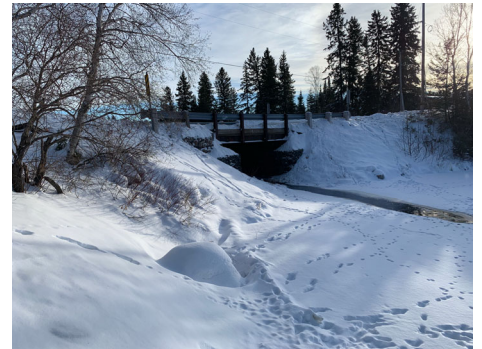
North elevation.

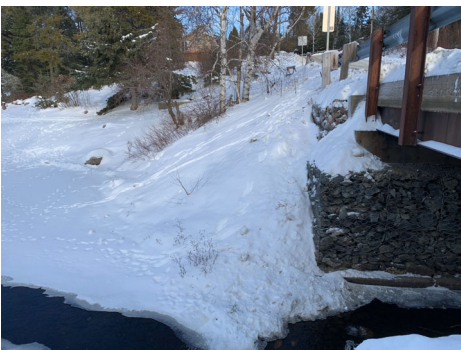
NE embankment.

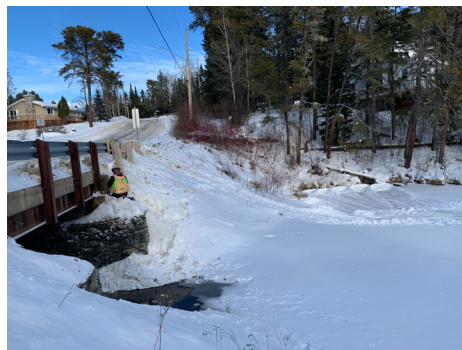
SE embankment.

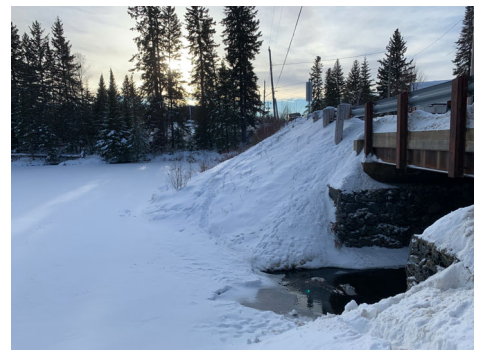
SW embankment.

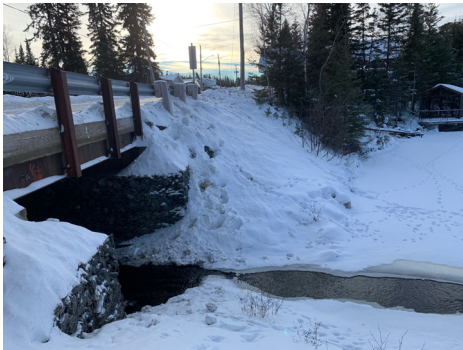
NW embankment.

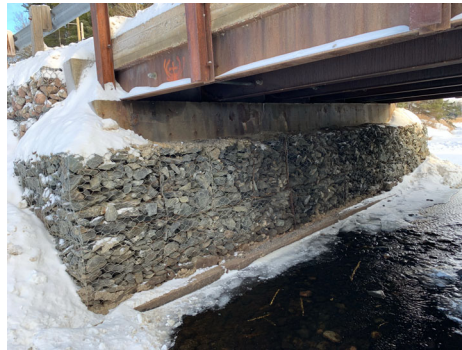
SU1 East abutment

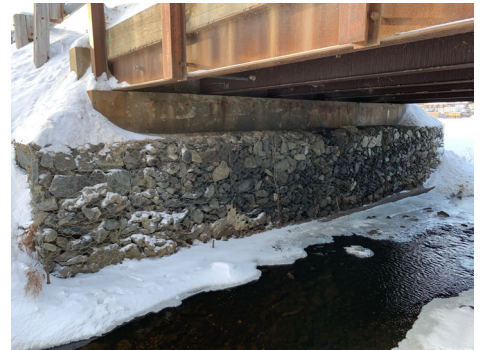
SU2 West abutment.

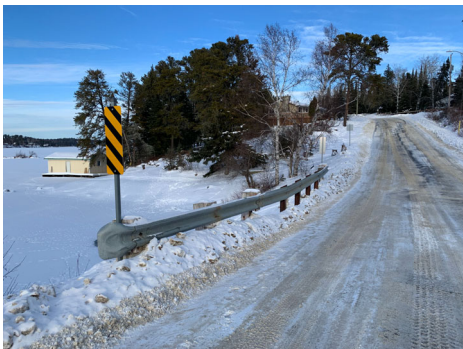
Typical North railing.

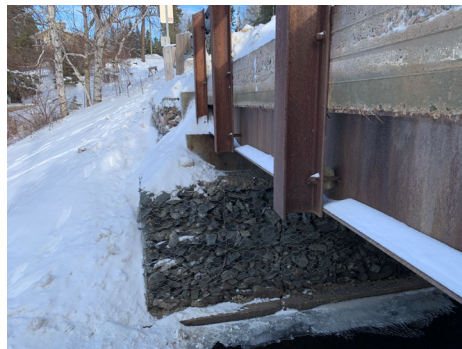
Typical North posts.

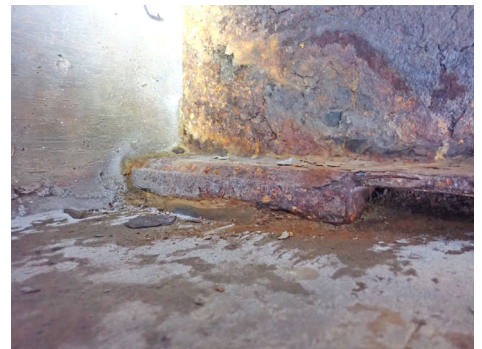
Typical interior bearing - SU1.

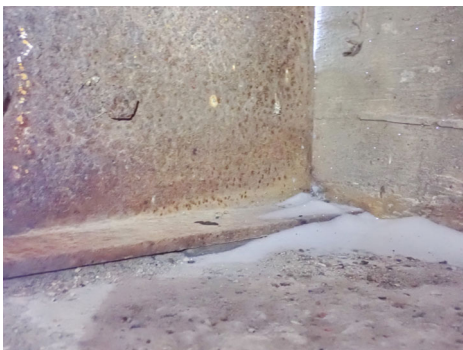
Typical exterior bearing - SU2.

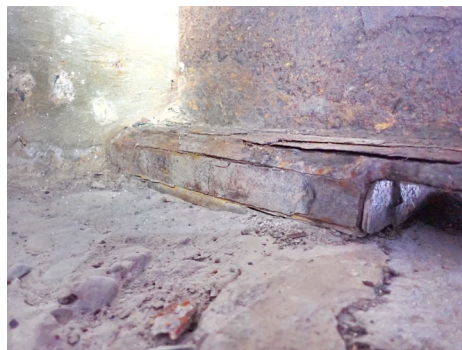
Typical interior bearing - SU2.

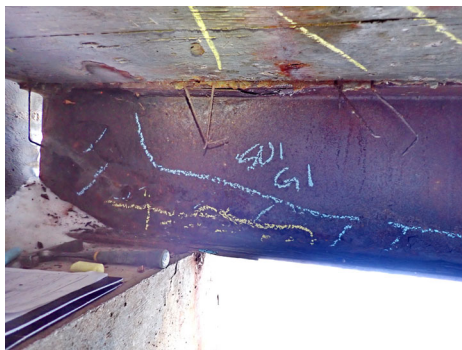
G1 @ SU1. Note: Typical corrosion.

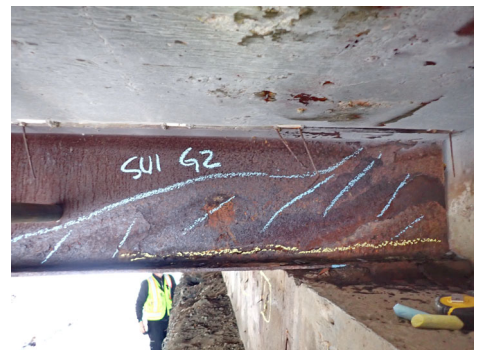
G2 @ SU1. Note: Typical corrosion.

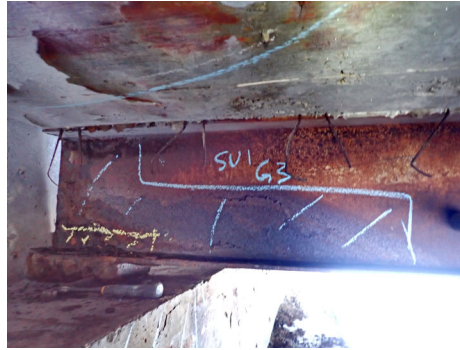
G3 @ SU1. Note: Typical corrosion.

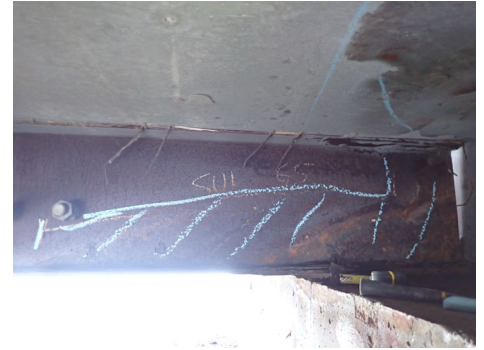
G5 @ SU1. Note: Typical corrosion.

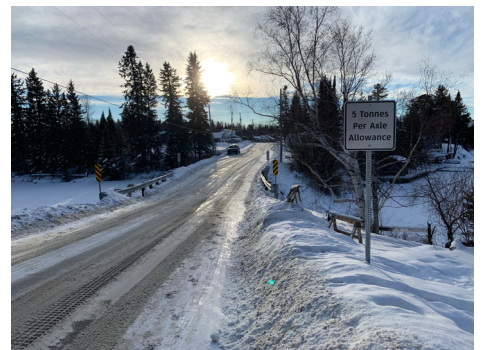
Typical Sign - NE.

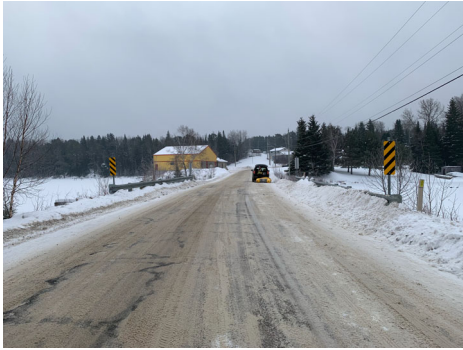
Looking South towards Barrel.

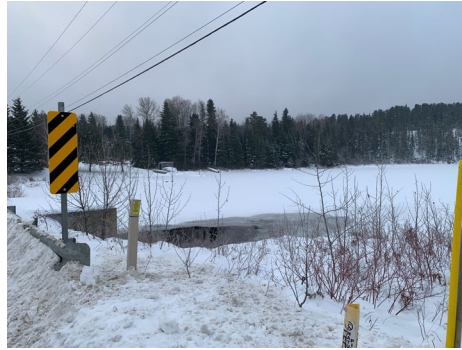
Upstream looking West.

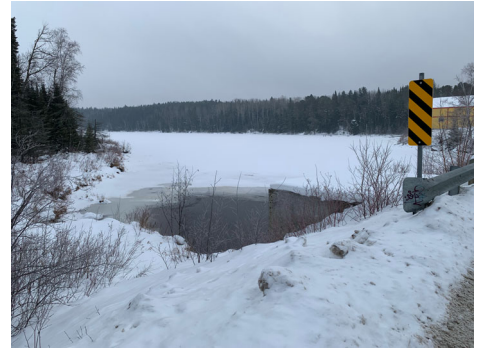
Downstream looking East

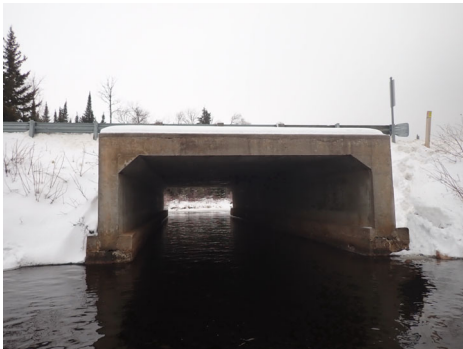
West elevation - Inlet

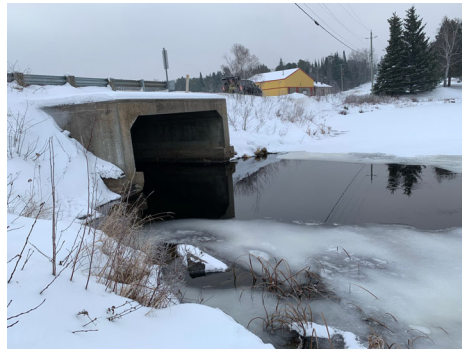
West elevation - Inlet.

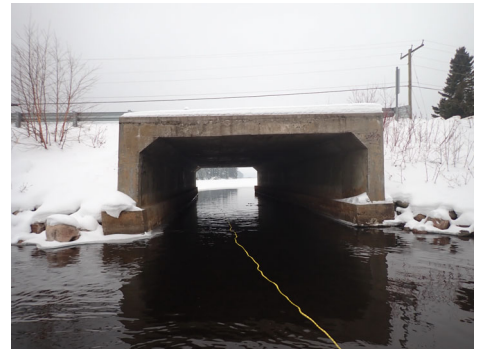
East elevation - Outlet.

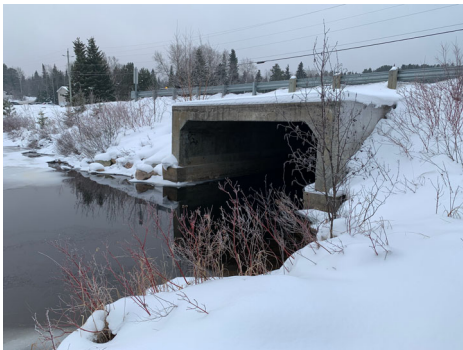
East elevation - Outlet

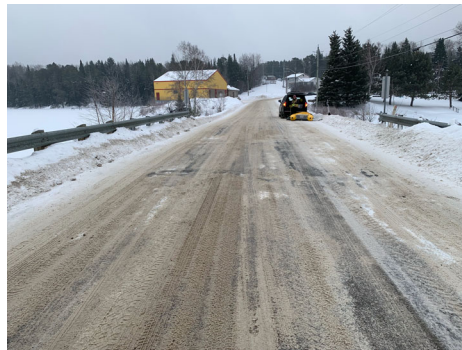
Typical wearing surface.

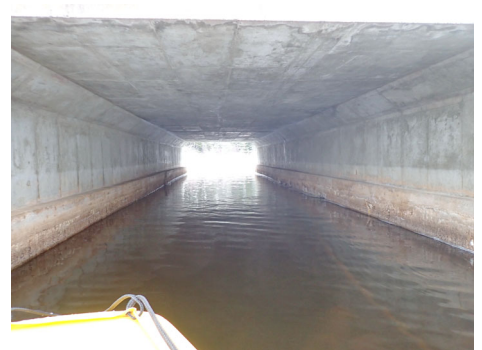
Looking East into barrel from Inlet.

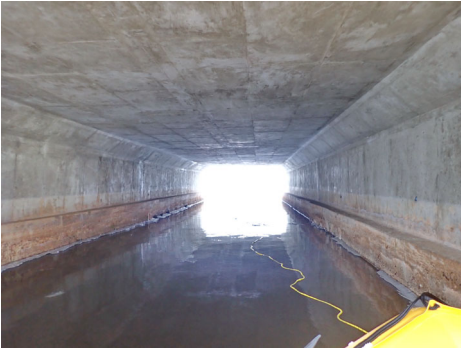
Looking West into barrel from Outlet.

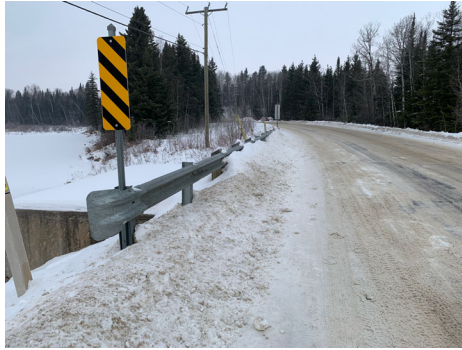
Typical West railing.

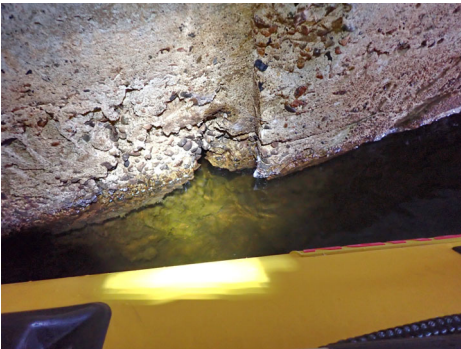
Culvert North Footing at midspan. Note:
Disintegration (~400mm deep) of footing with exposed rebar.

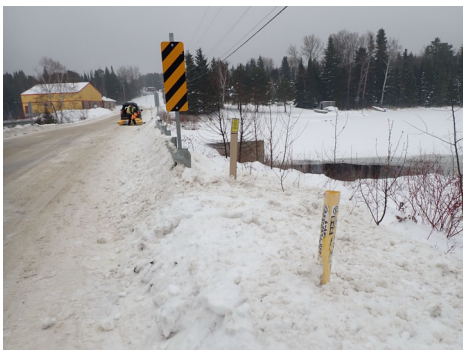
NW embankment. Note: Natural gas pipeline and cathodic protection markers.
